# PUBLIC ROADS

JULY-AUGUST-SEPTEMBER 1946

# A STUDY OF BITUMINOUS-COATED CORRUGATED SHEET METAL CULVERTS

BY THE DIVISION OF PHYSICAL RESEARCH, PUBLIC ROADS ADMINISTRATION

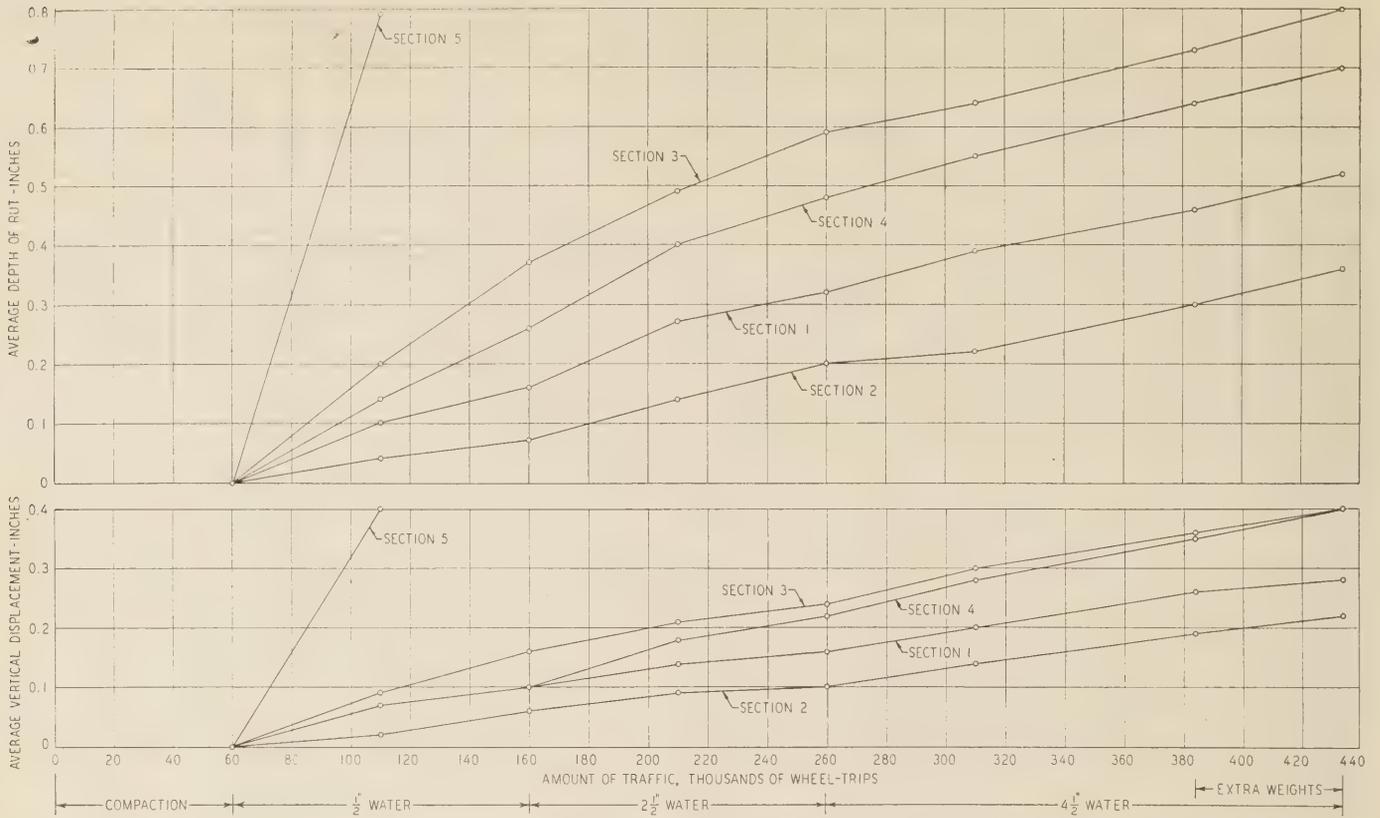
FIGURE 1.—SURFACE DISPLACEMENT OF SECTIONS OF THE TRACK DURING THE COURSE OF THE TEST.

Surface displacements of the sections at various stages of the test are shown in figure 1. The schedule of traffic applications and changes in water elevations with notations on the behavior of the five test sections are given in table 3.

Section 3, with a plasticity index of 9, was stable throughout the compaction period (60,000 wheel-trips). During the testing with concentrated traffic with water one-half inch above the top of the subbase, the section remained in good condition although there was a gradual development of ruts as shown by the displacement measurements plotted in figure 1.

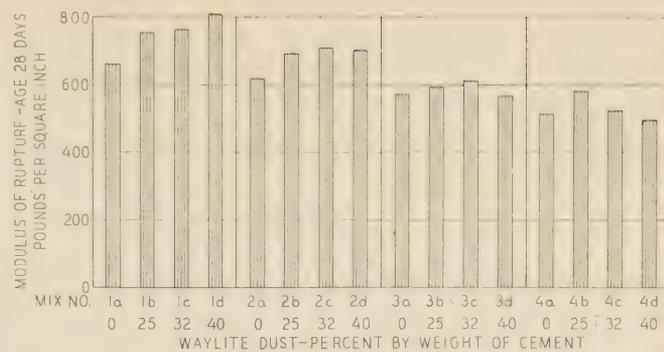
Results of strength tests of series A are given in table 5 and in figures 1 and 2. The flexural strengths shown in table 5 and plotted in figure 1 show how the percentage of Waylite dust in the mix affected the strength of concretes of varying cement content. Water-cement ratio as used in the discussion of series A refers only to the water-cement ratio of the base mix of each group, mix containing no Waylite dust. For total water content of mixes containing Waylite dust see table 3. It will be observed from figure 1 that in concrete for which the base water-cement ratio was 0.70, mixes No. 1(a) to 1(d), inclusive, the flexural strength

FIGURE 1.—EFFECT OF USING WAYLITE DUST AS A REPLACEMENT FOR PORTLAND CEMENT ON THE FLEXURAL STRENGTH OF CONCRETE, SERIES A.

increased as the percentage of Waylite dust increased, the maximum increase being 23 percent with 40-percent replacement. In the case of the group for which the water-cement ratio of the base mix was 0.80, mixes No. 2(a) to 2(d), inclusive, the maximum increase in strength was 15 percent with 32-percent replacement. In the case of the next group, mixes 3(a) to 3(d), inclusive, the maximum increase in strength of 7 percent was also found with the 32-percent replacement, whereas in the case of the last group, mixes 4(a) to 4(d), inclusive, the 25-percent replacement gave the highest strength, a 13-percent increase over the straight portland cement mix. In this instance the 40-percent replacement was slightly lower in strength than the straight portland cement mix, the 32-percent replacement showing about

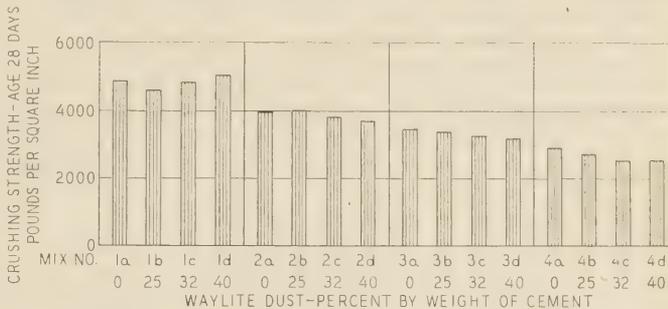
FIGURE 2.—EFFECT OF USING WAYLITE DUST AS A REPLACEMENT FOR PORTLAND CEMENT ON THE CRUSHING STRENGTH OF CONCRETE, SERIES A.

Crushing strength results for series A are also shown in table 5 and are plotted in figure 2. The use of Waylite dust as a replacement did not have the same beneficial effect upon the crushing strength of the concrete as is shown for flexural strength. For example, for the mixes in which the base water-cement ratio was 0.8 or higher, the strength of the concrete containing Waylite dust was in most cases slightly lower than the corresponding straight portland cement concrete, the percentage of reduction increasing as the amount of Waylite dust used as a replacement was increased. In the case of the group for which the base water-cement ratio was 0.70, the strength of the concrete containing the Waylite dust was approximately the same as that of the straight portland cement concrete.

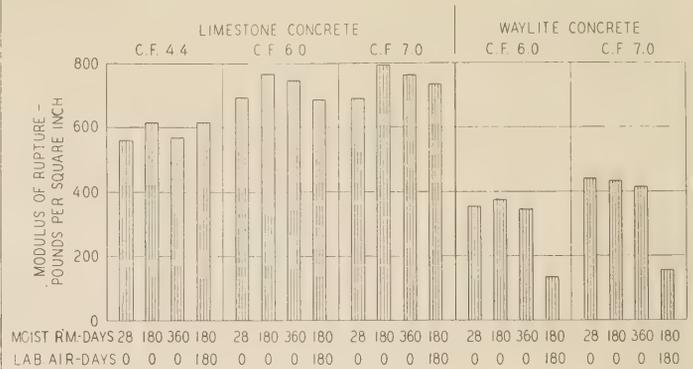
The flexural strengths of the limestone concrete and the Waylite concrete can be compared by studying the individual panels of figure 3. For example, the second panel gives the flexural strength of the 6-sack limestone concrete, while the fourth panel gives the strength of

FIGURE 3.—EFFECT OF AGE AT TEST AND METHOD OF CURING ON THE FLEXURAL STRENGTH OF CONCRETE CONTAINING NATURAL AGGREGATES AND WAYLITE, SERIES B.

the 6-sack Waylite concrete. The moist-cured concrete containing the Waylite aggregates developed only about one-half the strength of the limestone concrete. The same general trend applies to the 7-sack mixtures.

In general, the data shown in figure 3 indicate that the strength of the Waylite concrete was about one-half of that obtained with comparable concrete (same cement content) made with natural aggregates when the test specimens were cured continuously moist. For specimens tested at 360 days, which were subjected to 180 days of moist curing followed by 180 days of air curing, the strength of the Waylite concrete was only about one-fifth of the strength of the concrete made with the natural materials. The limestone used in these tests is of a nature that tends to produce high-strength concrete, particularly in flexure.

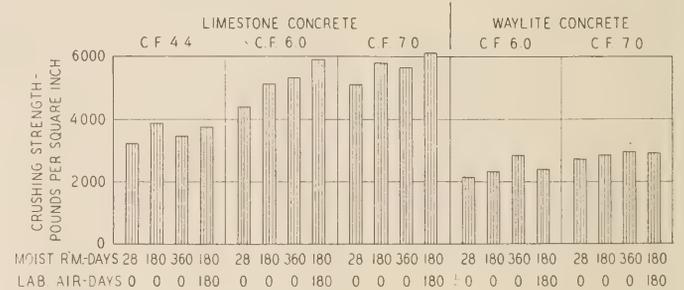
FIGURE 4.—EFFECT OF AGE AT TEST AND METHOD OF CURING ON THE CRUSHING STRENGTH OF CONCRETE CONTAINING NATURAL AGGREGATES AND WAYLITE, SERIES B.

Crushing strength data are shown in table 6 and plotted in figure 4, the arrangement being the same as in figure 3. For the continuously moist-cured specimens the results agree very closely with those obtained in flexure, the Waylite concrete giving about half the strength of the limestone concrete for equal cement content and about two-thirds for equal water-cement ratio. However, specimens cured moist for 180 days followed by 180 days' curing in air did not show the retrogression in strength that was found with the flexure specimens. This applies both to the Waylite concrete and to the limestone concrete. In fact, the limestone concrete subjected to the air curing gave about 10 percent higher strength than did the specimens cured continuously moist.

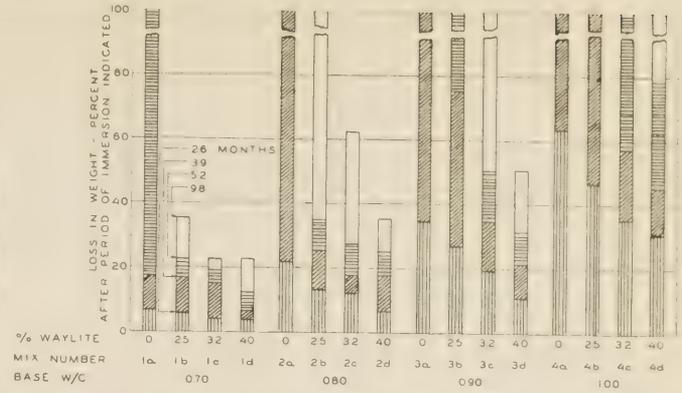
Periodic examination was made of the cube specimens from series A which had been immersed in sulphate solution, and the losses in weight, based on the wet weight of the specimens at the time of immersion, were determined. These losses, computed on a percentage basis, are given in table 7. They are also plotted in figure 5 in a manner to bring out the effect of richness of mix and also the effect of varying the quantity of Waylite dust used as a replacement. The water-cement ratios for the base mixes, mixes containing no Waylite dust, and the percentages of replacements were, of course, the same as in series A (see table 3).

The bar diagrams in figure 5, which extend to 100 percent, are broken for the reason that in no case did complete disintegration occur at exactly 39, 52, or 98

FIGURE 5.—EFFECT OF USING WAYLITE DUST AS A REPLACEMENT FOR PORTLAND CEMENT ON RESISTANCE OF CONCRETE TO ALKALI ACTION, SERIES C.

months but at some time between these periods and the time previous weight determinations were made.
